DIY FIX IT

BY JON PINKERTON
& RALPH SKEA

This is part two of a two part article on making basic repairs to your PT. In this part, repairs to foam composite boats are addressed.

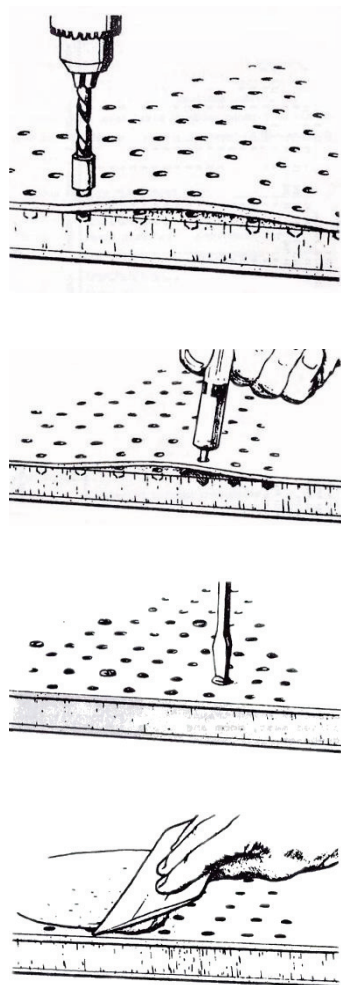
Section 4.2.2 addresses the use of a fibreglass backing patch to reinforce hull and deck repairs (similar to the ply one described in the previous DIY article on timber hull repairs). This can also be a useful technique if a section of hull is to be removed and reinstalled in order to gain access to internal damage such as centrecase leaks or split decks (see pics opposite).

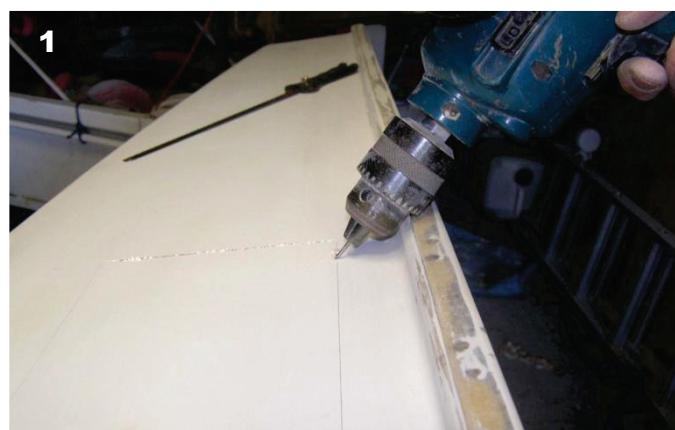
If acquiring foam for your repairs is an issue, plywood can be used as the core material (and the backing piece, but seal it). If you don't have an angle grinder, GENTLY saw a 1.6mm drill sideways along the line to create a starter slot for the hacksaw blade (Pic. 1). Angle the

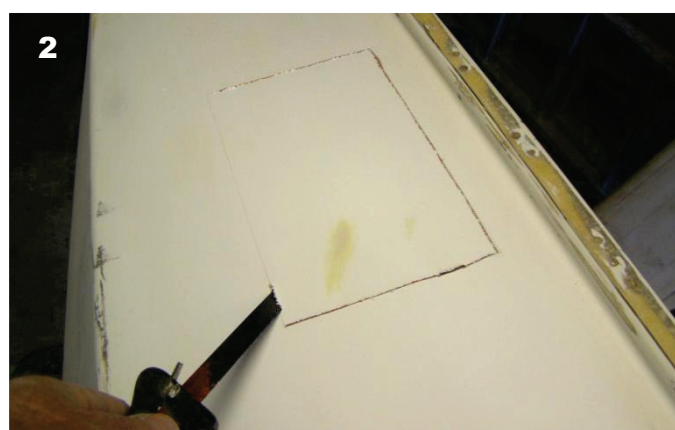
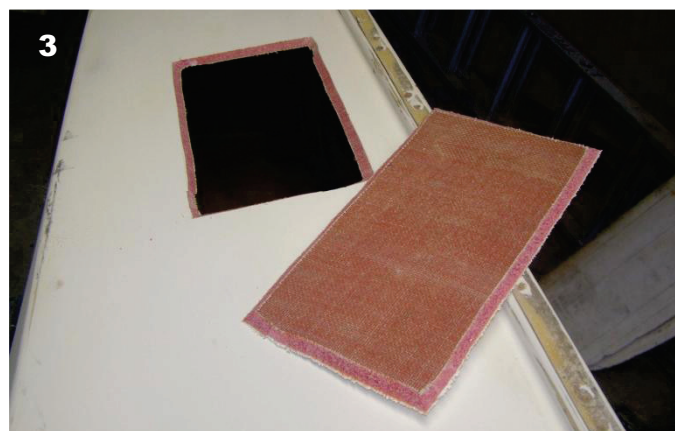
blade at the corners to allow for the bevel (Pics 2 & 3). A backing piece is recommended when replacing the patch. If the patch is in a high impact area, carefully sanding the gelcoat back to (not through) the glass layer along the patch joint and adding 25mm wide fibreglass tape is advisable. Then use epoxy filler to blend the patch with the panel.
