FASTSAFE

Keeping it together under pressure

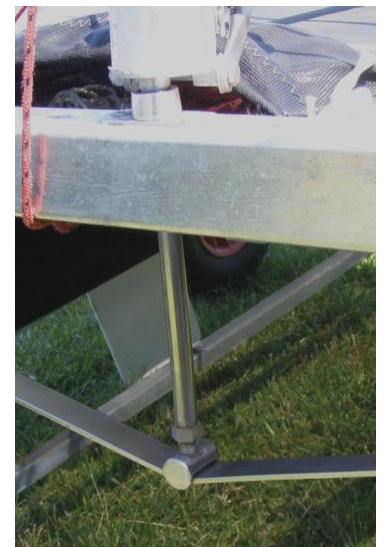
Next you should check where the strut presses against the strap. Desirably the foot of the strut should cover the full width of the strap. If it doesn't, look for any deformation or cracking of the strap as this could indicate early signs of impending failure. The strut should also be designed to prevent the strap from sliding fore and aft.

Firstly, the strut should be held perpendicular to the lower surface of the main beam. It usually passes through the bottom of the beam and is held in place by a bolt or pin through the top surface. It must not be able to move fore and aft or sideways and should be straight. Also check for corrosion where it is attached to or pierces the bottom of the beam.

Finally check the attachment points at each end of the strap. The minimum bolt diameter used to attach the strap should be 8mm. The inner bolts where the strap bends (which take the greater load) are shown on the plans as a larger diameter than the outer bolts. However, if the inner bolt fails, a smaller outer bolt is unlikely to save the day. An extra few grams is not going to lose you a race or series but a broken main beam will.

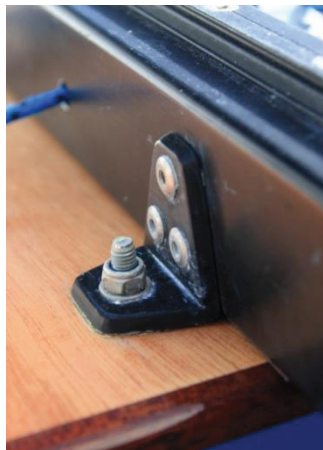
NZ style inner beam bolt

Twisting of the hull platform whilst sailing places high stresses on the beam bolts. If the bolts are strong enough to withstand the load, these stresses are taken by the lower beam surface and the hull beam pads. The inner bolt positions on the rear beam are particularly vulnerable to damage.

Check for any gap between the deck and the beam. It should not be possible to slip anything between them. If there is a gap, it could indicate that the bolts are loose, or that the bottom surface of the beam is distorting around the bolt, or that the beam pad is compressing. In a worst case scenario the bottom face of the beam can crack and pull away from the sides.

If the beam and pads are sound, tighten all bolts firmly. If the beam is distorting or the pad is compressing, fix the beam and add large washers or 3mm thick aluminium plates to distribute the load away from the bolt hole. If the beam has cracked, a new beam will probably be required as welding may soften the tempered aluminium.

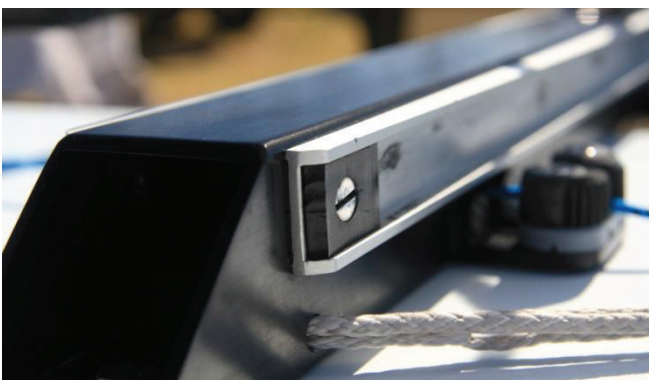
Low profile traveller

Gybing in a strong breeze can subject the ends of the traveller track to considerable upward forces, and the stops at the ends of the track will also cop a hiding if the traveller car hits them. The traveller control line should desirably stop or cushion the traveller car before it hits the stops. If the stops fail and a ball bearing traveller car leaves the track, the bearings may be lost.

Check that the track is not pulling away from the top of the beam and replace fastenings if necessary. Consider using bolts rather than rivets to hold the ends of the track. Check the track end stops for cracking or distortion and bent fastenings. Repair or replace as required.

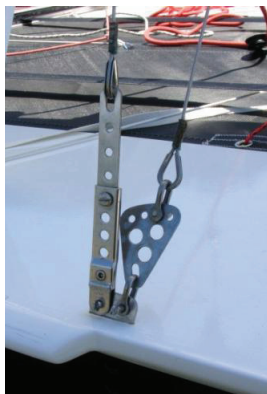
Shackles are one of the hardest working and reliable PT components. However, they can fail with age. If the shackle has distorted, it is possibly too small for the task.

Check all shackles. If the pin is worn and loose or hard to screw in due to distortion of the shackle body, consider replacement.
