DIY FIX IT

BY JON PINKERTON
& RALPH SKEA

This is part two of a two part article on making basic repairs to your PT. In this part, repairs to foam composite boats are addressed.

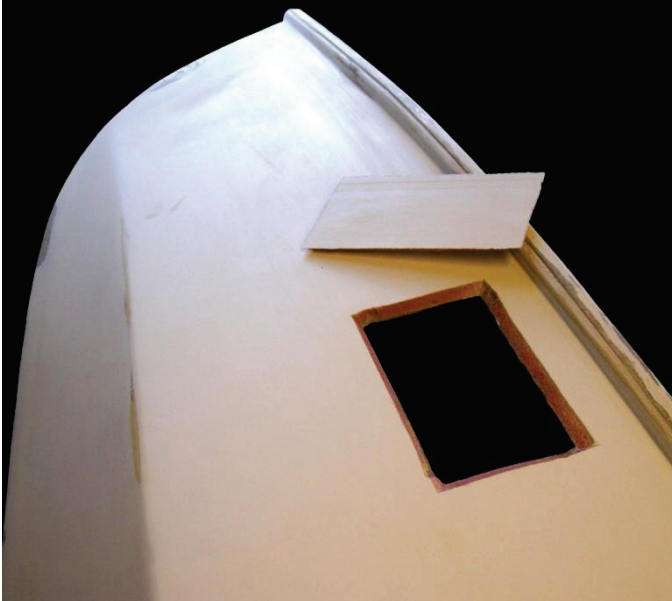
The next step requires a very delicate hand, as you will find diamond saws are not forgiving when used. Veery carefully, feather the existing gel coat and fibreglass back away from the cut to expose a margin of around 10mm to 15mm of bare virgin foam, another 10mm to 15mm of the fibreglass laminate, and finally the same margin of gel coat. Be extremely careful not to cut into the surface of the foam.

Take the grinder and plunge it into the hull on the marked lines at an angle of about 45 degrees to the hull surface, cutting all around to remove all the broken pieces. Inspect inside [torch and mirror] to make sure all the fractures are removed. If not, re-mark and re-cut. The precision of this cutting will make fitting of the patch easier.

Now cut the foam sheet to intimately fit the cut out. The accuracy of the fitment of the foam will determine the overall integrity of the repair, so be very careful and do it bit by bit to achieve a perfect job. When the patch is placed in the cut out, you need the surface of the patch about 3 thicknesses of paper lower than the already exposed surrounding foam.

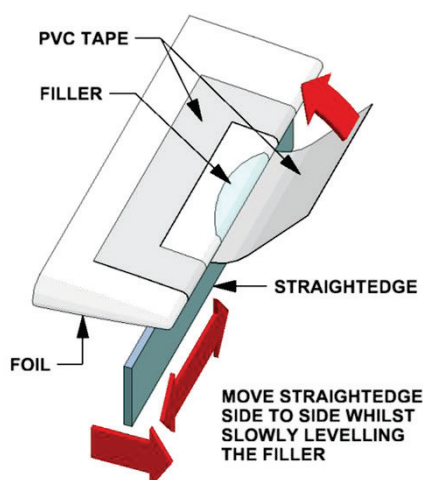
Minor damage to the centreboards and rudders is dealt with in a similar way to minor hull surface damage. If the damage is on the leading or trailing edges, bevel the edges of the damaged area to give a longer bond area. Now mix filler and pigment to match the foil colour and proceed as above to fill the damaged area, using PVC tape and a straightedge to form the filler around the edge to match the shape of the board. When the damage is properly filled, carefully sand level with the foil surface, then polish.

If the damage is more severe, rebuild the foil with foam (or lightweight timber) then repair the surface fibreglass and gelcoat layers as described in the section on foam sandwich skin repairs.
